CAPSIZING/SWAMPING ACCIDENT INVESTIGATIONS FOR 1977 SEASON.(U)

APR 78 J CLARKE, J ELDREDGE, W MUHLER

1. Report No. CG-D-62-78		2. Government Accession No.		3. Recipient's Catalog No.	
4. Title and Subtitle Capsizing/Swamping Accident Investigations for 1977 Season		5. Report Date April 1978		6. Performing Organization Code

16. Abstract This report details the results of seven in-depth boating accident investigations. The accidents were selected from 78 capsizing/swamping accidents reported by Coast Guard and state units. The procedures for selecting accidents for investigation are detailed. Summaries of each accident investigated are given. Each of the accident investigation reports are attached as appendices to the report.

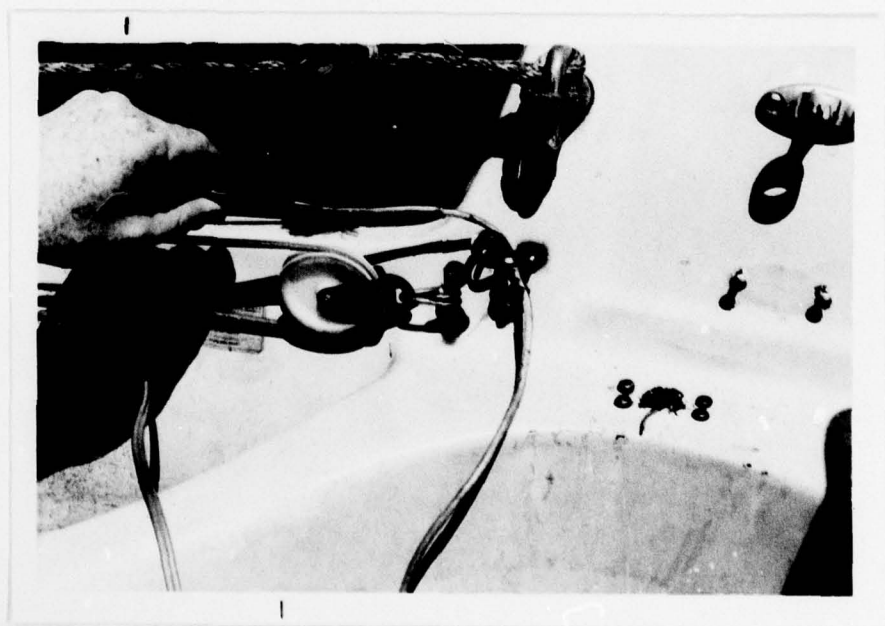
During the investigation close inspection of the steering cable indicated a frayed area where the endclamp had broken free. The endclamp connection was still tight when the boat was inspected. The tail end of the steering cable was excessive in length, allowing entanglement with other objects in the boat. This entanglement in turn would increase the tension on the endclamp of the system. In addition, the cable connections on the starboard side were improperly installed causing a crossover of the cable and improper distribution of the tension. It is felt that a contributing cause of this accident was the improper installation of the mechanical cable steering system. The crossover of the steering cable on the starboard side of the system resulted in additional tensions on the cable. The frayed area on the cable near the endclamp indicated that the situation had been developing for quite some time. The excess cable on the trailing end allowed entanglement with other gear in the boat, especially in conditions such as the day of the accident, which resulted in shear tension on the endclamp. A lack of maintenance of the steering system cable allowed for a gradual deterioration to the point of endclamp failure. Therefore, the choppy water conditions, intensified by the speed with which the boat was travelling, aggravated the pressure on the endclamp causing failure of that part. The decrease in the control of the steering system allowed the torque of the engine to swing it from side to side. The interaction of the chop and the "freer" motion of the engine caused the release of the tension clamp on the starboard side of the steering system. This in turn intensified the rocking action caused by the engine. By this time the rocking and skipping of the boat had become quite violent and it is believed that the hard chine of the whaler hull shape caught a wave capsizing the boat to starboard.

Figure 7
FRAYED PORTION
OF STEERING CABLE FROM WHICH END CLAMP WAS RIPPED

an example of the type of cause and effect relationship associated with the lack of proper maintenance. It therefore could prove useful as an example of the results of careful routine inspection of even seemingly inconsequential parts such as the endclamp of a steering system.

It is recommended that consideration be given to a thorough evaluation of the accident causal role of steering systems. Promulgation of steering system guidelines for installation and maintenance could have played a role in reducing the probability of this accident.

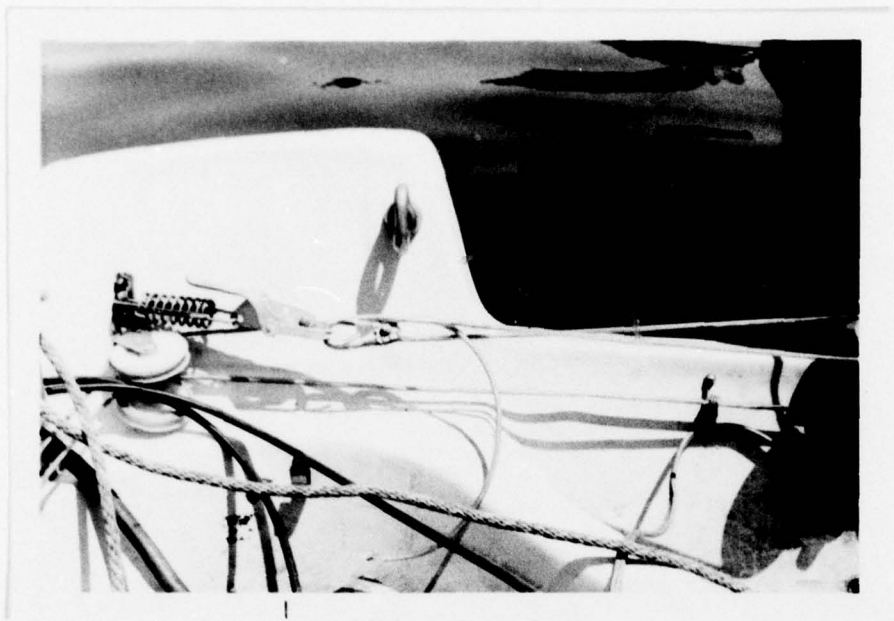
Figure 8
TENSION CLAMP CLOSED
NOTE CROSS OVER OF CABLES

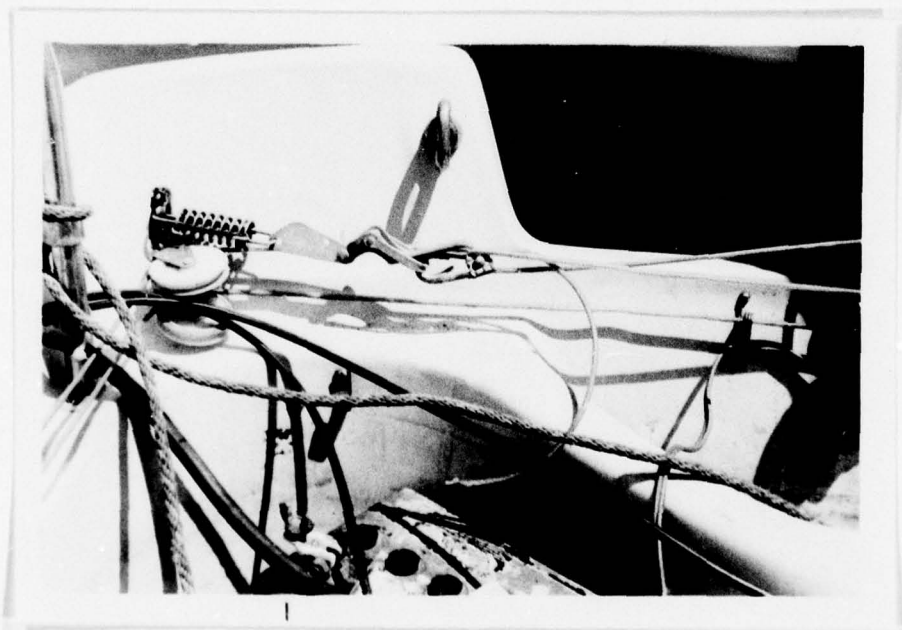
Figure 9
TENSION CLAMP OPENED

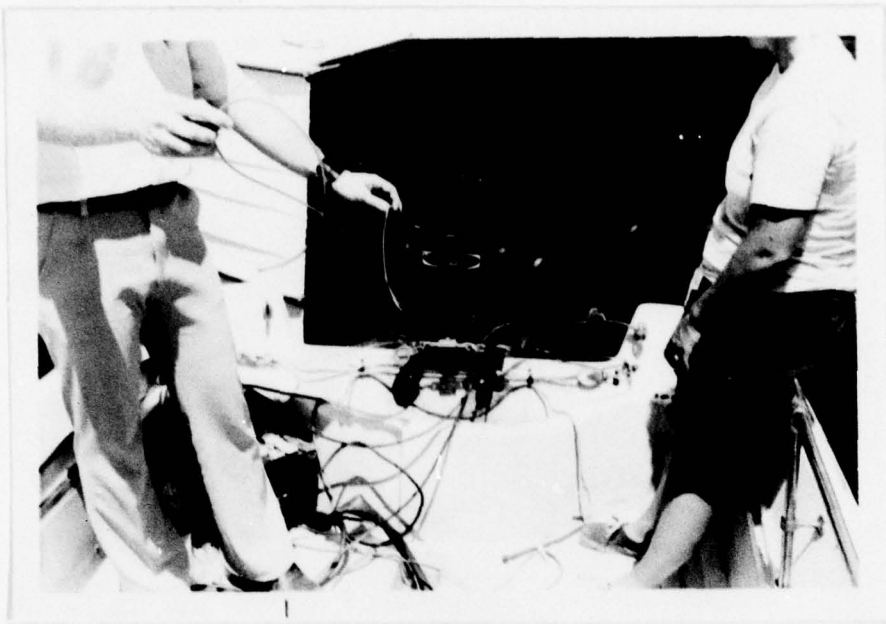
Figure 10
EXCESS CABLE AFTER END CLAMP

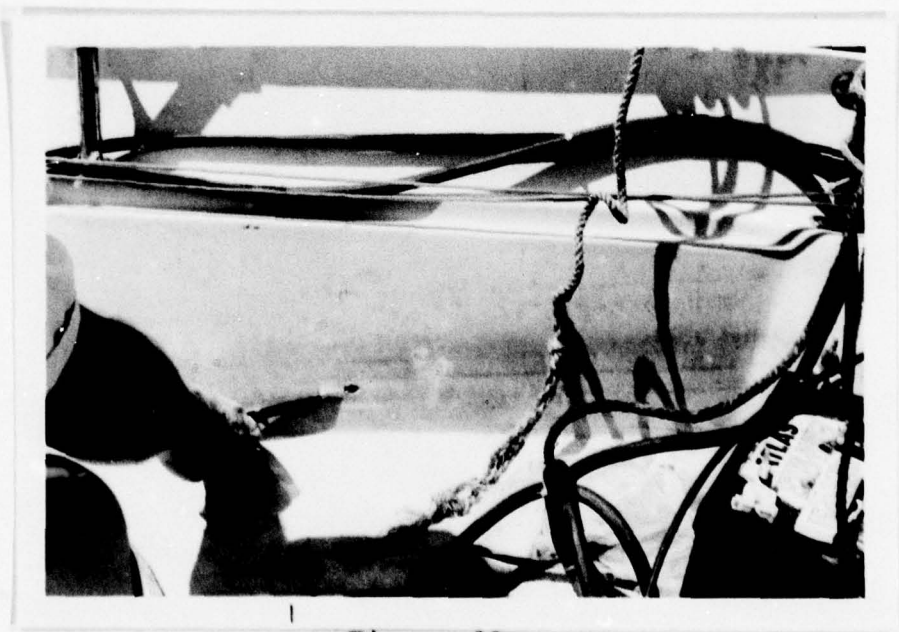
Figure 11
PUNCTURE INCURRED DURING CAPSIZING

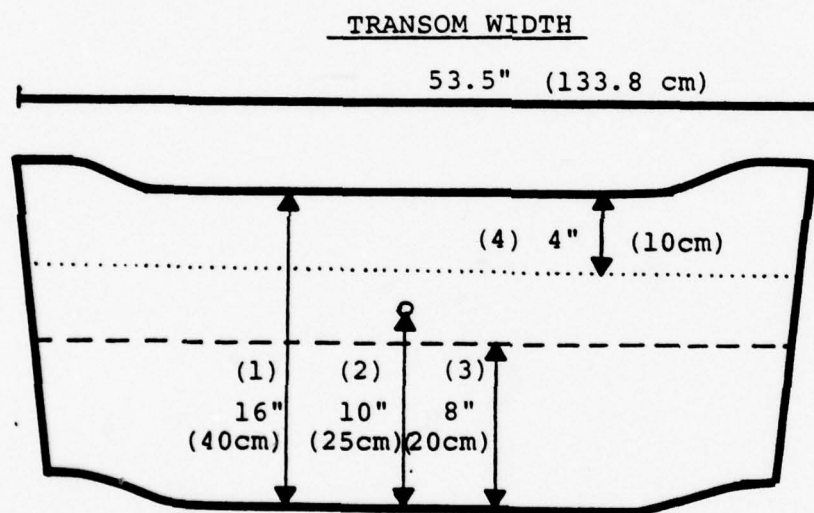
The major contributory factors were the runabout's extremely low freeboard (6", 15 cm, at the transom) (refer to Figure 4), and the loading of the stern with 3 passengers, motor, partly full gas tank and tackle box. There is no doubt that the operator complied with the maximum load restrictions as set forth by the capacity plate. There is also little doubt that the runabout fits the loading requirements as set forth by the capacity test system. However, what passes as seaworthy in a laboratory might not under actual sea conditions.

FIGURE 4
VIEW OF TRANSOM FROM STERN

We recommend that the maximum safe loading criteria as outlined by the runabout's capacity plate be reviewed as to its utility in sea conditions where waves range from 1-4 ft. (.3 - 1.2 m) in height. A transom height of 6" (15 cm) resulting from the loading of the runabout up to maximum capacity is not safe under sea conditions such as these.

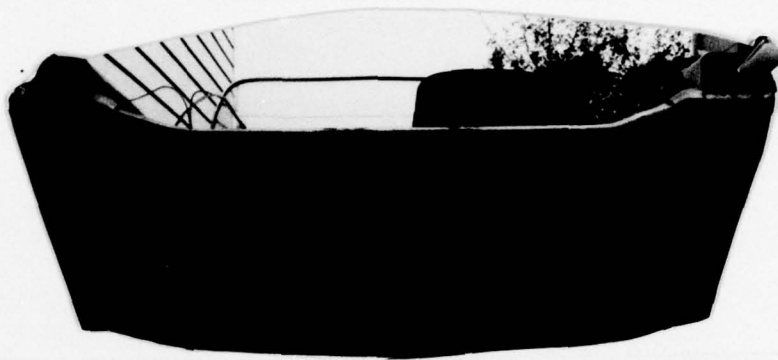
FIGURE 8

NOTE TRANSOM WATERLINE ABOVE MOTORWELL DRAIN
